## Bird's eye view of the landslide of 25 Oct 2026 that claimed one life

**Evidence from historical satellite images show that the slope immediately behind the houses along Lebuhr Rambai 13 have been unstable, and that ad-hoc measures had previously been taken to correct past slope failures.**

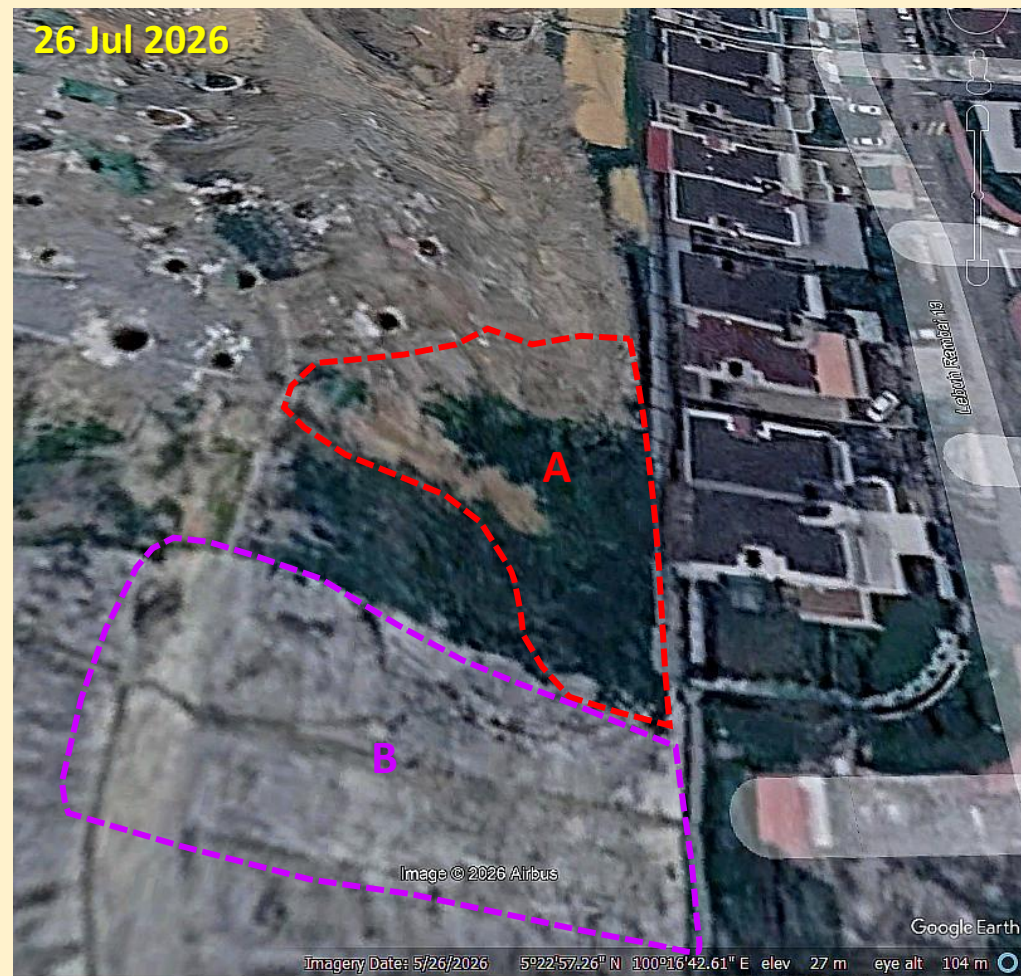
This Google Earth (GE) image of the area 3 months before the landslide shows area A was partly cleared of vegetation

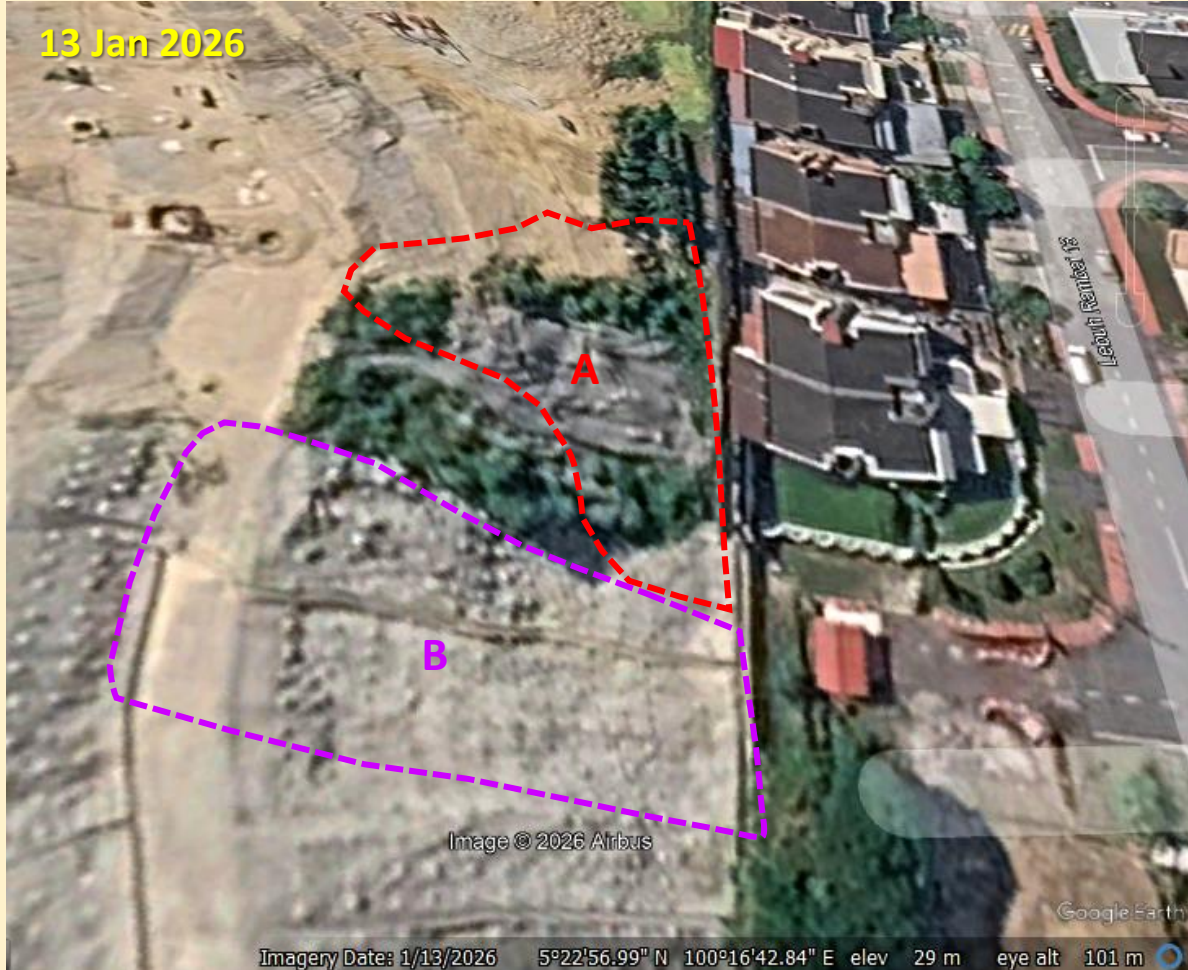
This Jan 2026 GE image shows that there was already a partial cementing of the slope in area A , indicating a slope failure would have happened there. Area B had been cemented over.

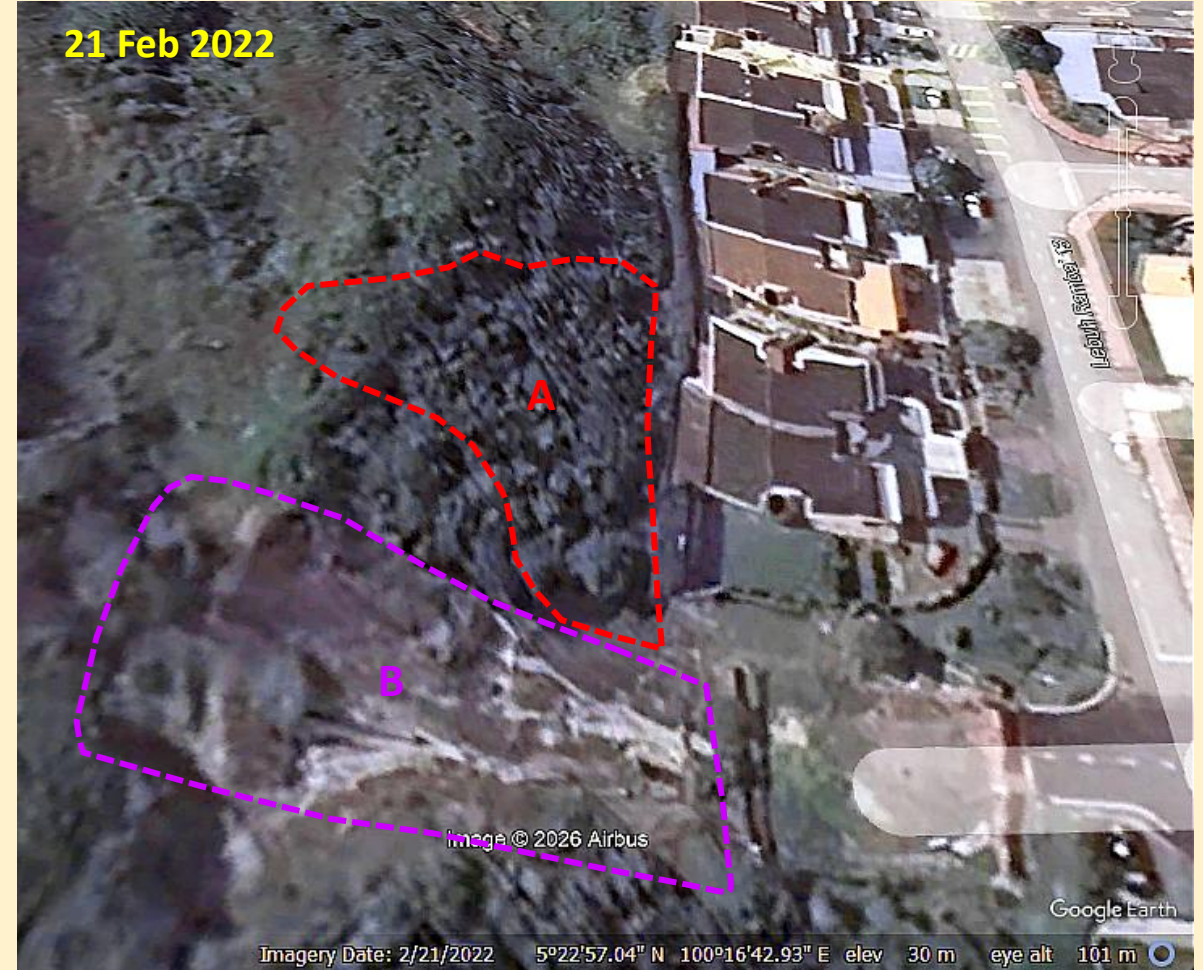
This Feb 2022 GE image shows bare surface left exposed in Area B when an earlier cement cover got worn down.

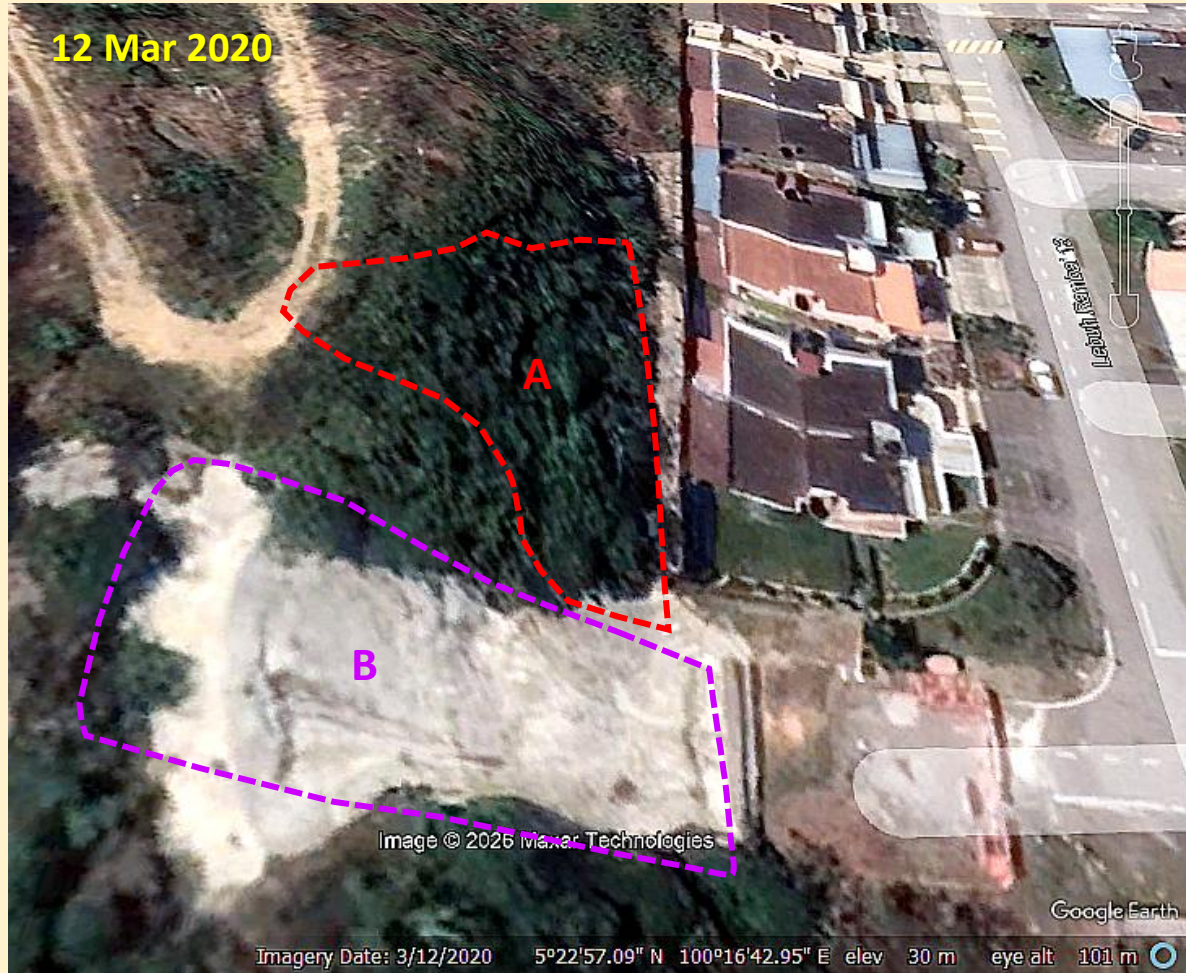
**This Mar 2020 GE image shows Area B had previously been cemented over, indicating a slope failure would have happened there.**

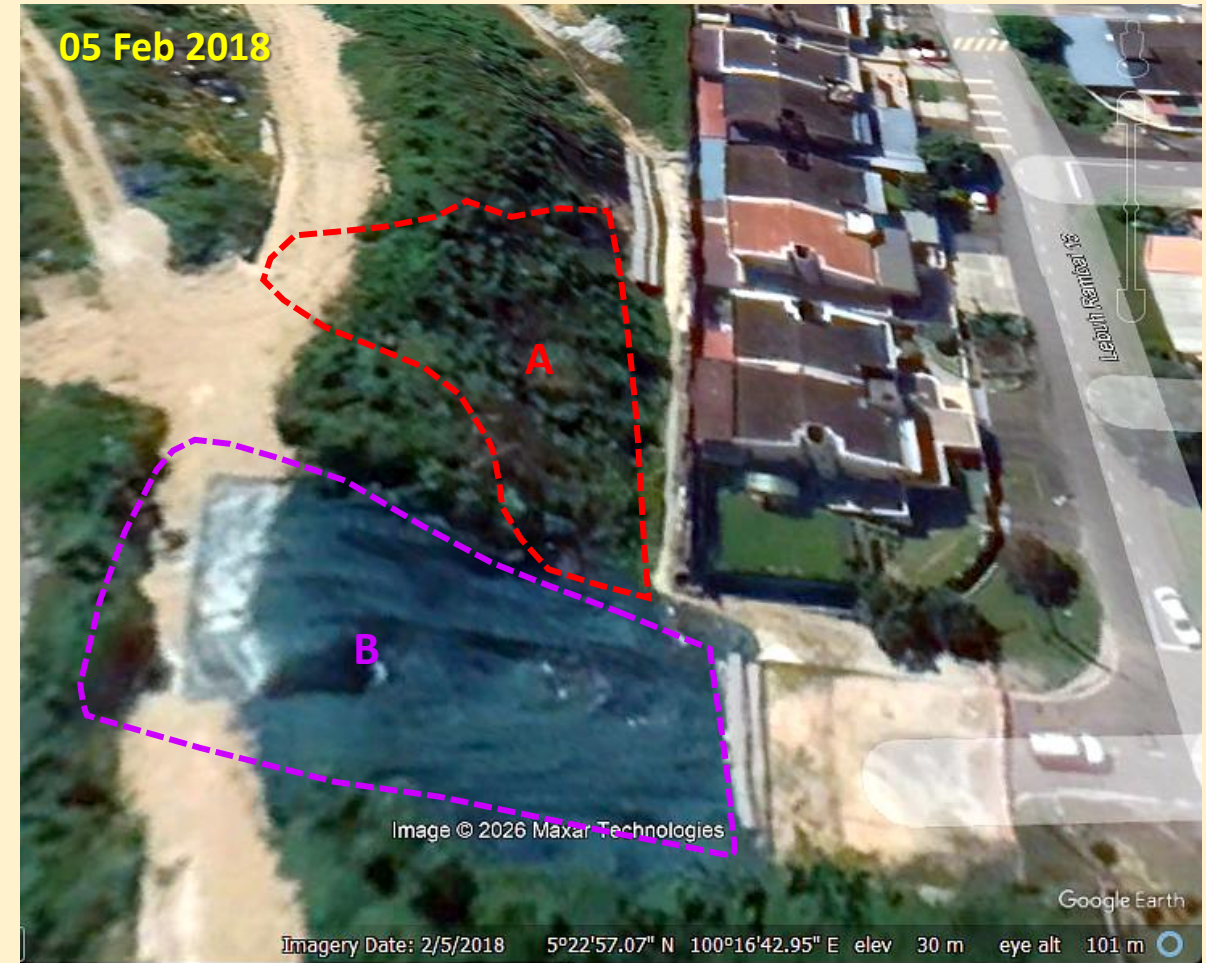
**This Feb 2018 GE image shows blue plastic sheet covering Area B, indicating a slope failure would have happened there.**
